ARROW AIR INC.
DOUGLAS DC-8-63 N950JW
GANDER INTERNATIONAL AIRPORT,
NEWFOUNDLAND

12 DECEMBER 1985

REPORT NUMBER 85-H50902

DISSENTING OPINION

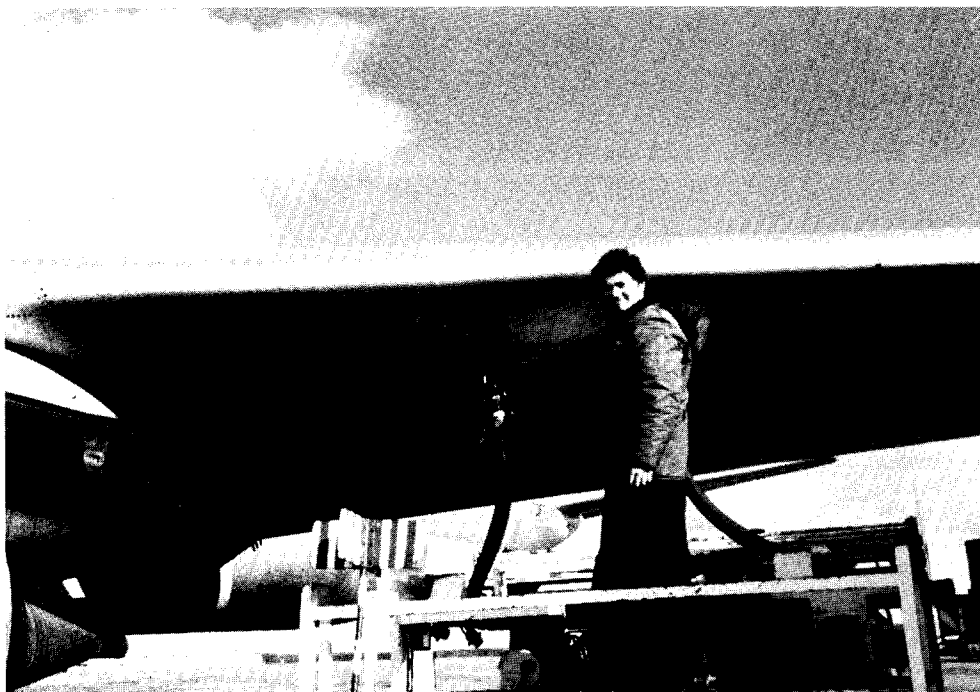
Figure D01. Refueller's view of DC-8 leading edge

Two refuellers who could not fail to see the leading edge while connecting the fuel hose to the refuelling panels (see Figure DO1.) testified that they saw no ice. Had de-icing been necessary, it could have been provided on a fee-for-service basis. None of the four ground handlers who would have done the work noticed any ice. Earlier that morning, one of these workers recommended de-icing to the captain of an aircraft that had been at the airport for some time. This witness stated that the Arrow Air DC-8 did not need de-icing because there wasn't any ice on it.

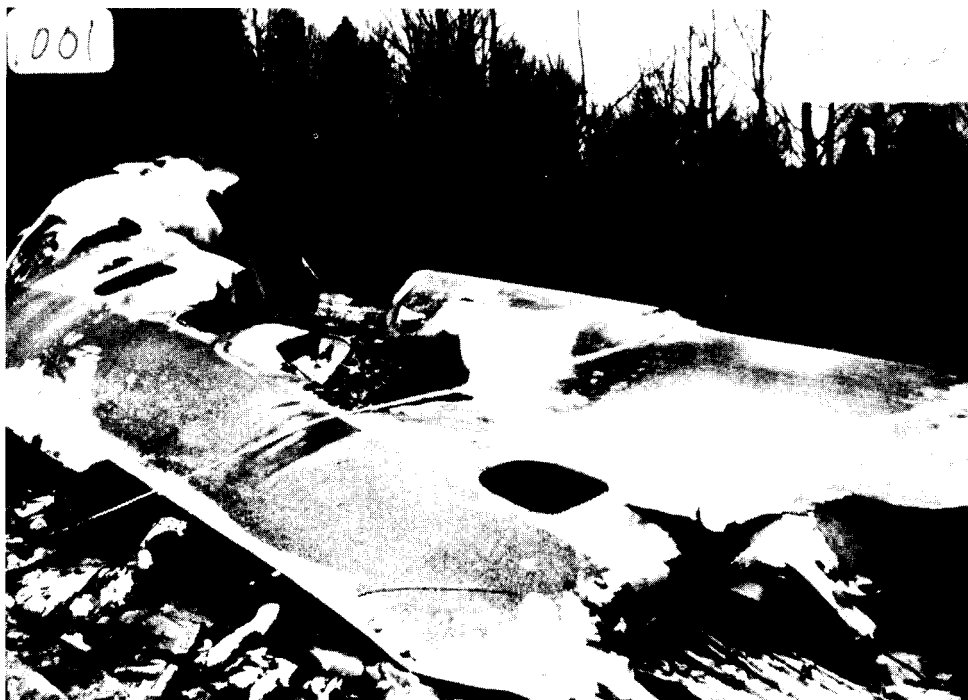
Figure DO4. Fire-damaged fuselage section

We were particularly interested in the continuity of soot patterns between the edges and frames of doors, emergency exits, and access hatches. As can be seen on Figure DO4., sections of the fuselage with missing doors and windows and evidence of heat discoloration were available for study. We do not know how many doors were recovered, but photographs show that a number were available for analysis. Figure DO5. shows one of the emergency exits. Soot around the edges and blistering of the paint indicate that it had been exposed to severe fire. An attempt to mate this exit with its frame may have helped establish whether the fire occurred in the air or on the ground.

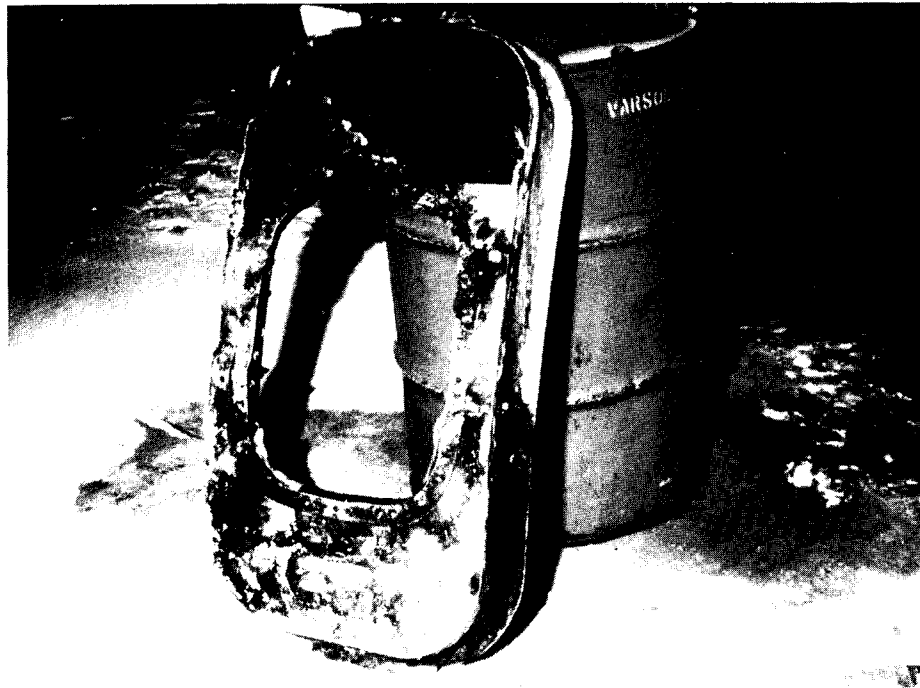
Figure DO5. Emergency exit showing soot deposits around edges

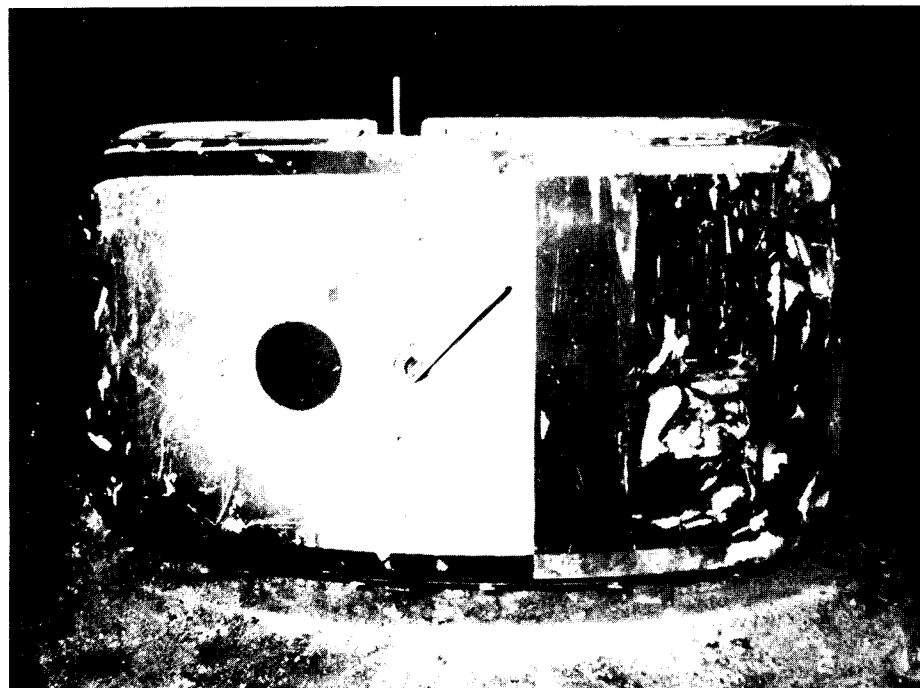
Figure DO6. Exterior of damaged door

Figure DO6. shows the exterior surface of another door with fire evidence on the edges. This door shows post-crash damage, but no evidence of buckling that might be expected if impact forces had been transferred through the frames. Figure DO7. shows the inner surface of the same door. The burn marks spreading from one edge could suggest that an internal fire may have burned out the seal while the door was still attached. We note that the fire which damaged the upholstery and exposed the frame near the window did not melt the window's outer layer.

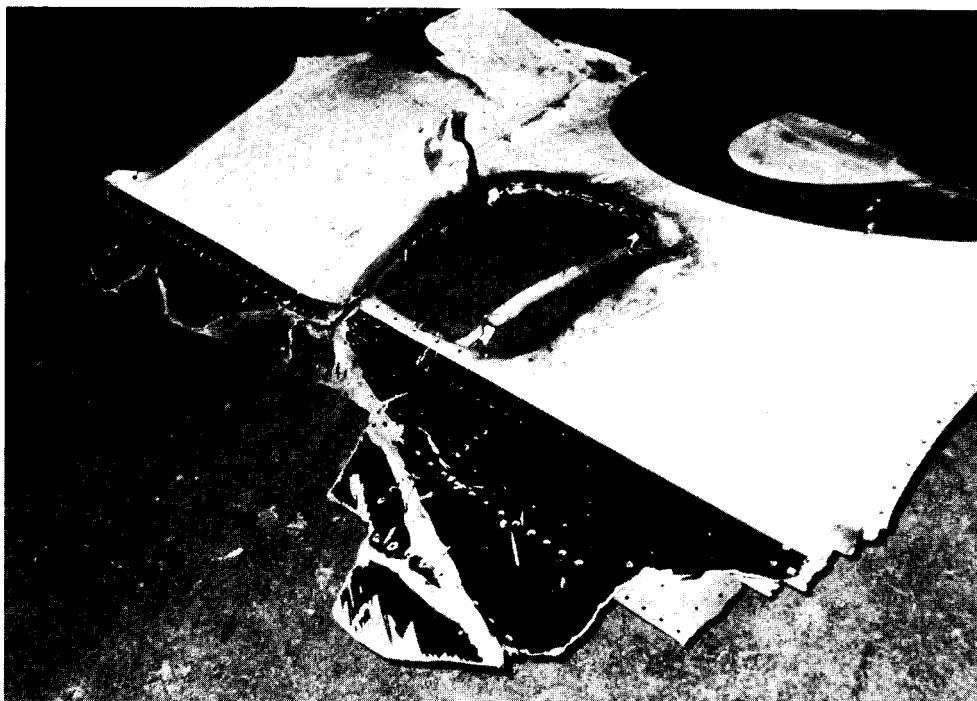
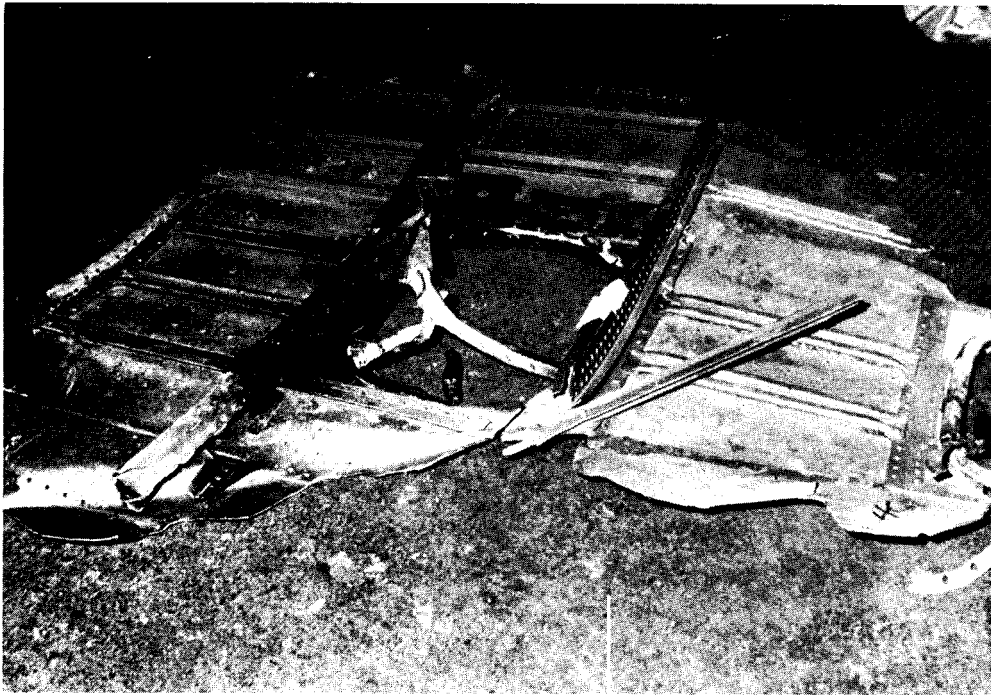
Stronger evidence can be observed on Figure DO8. and Figure DO9. which show exterior and interior surfaces of a section of fuselage around a window. Lack of burn evidence on the frames of the adjacent windows indicates a highly localized fire originating on the inside. The soot surrounding the exterior of the empty window opening suggests a flash from an explosion which shattered the window. The relatively light burn marks on the interior also suggest an explosion, since we would expect more severe burning from a fire sufficiently intense to melt both layers of the window. More concrete evidence may have been obtained from detailed microscopic analysis of the window edges.

Figures DO8. and DO9. provide convincing, if not conclusive, evidence that the soot was deposited around the window before the section separated from the fuselage. The fracture surface near the lower edge of the window opening is free of soot deposits or other evidence of exposure to fire. The piece of frame which separated from the top of the window also left a strip clear of soot. Thus, a fire must have occurred before the section separated; that is, before the crash. Since the part in question has been discarded and we could find no other photographs, we were unable to further substantiate this finding.

Figure D08. Exterior surface of fuselage section

Figure DO9. Interior surface of fuselage section

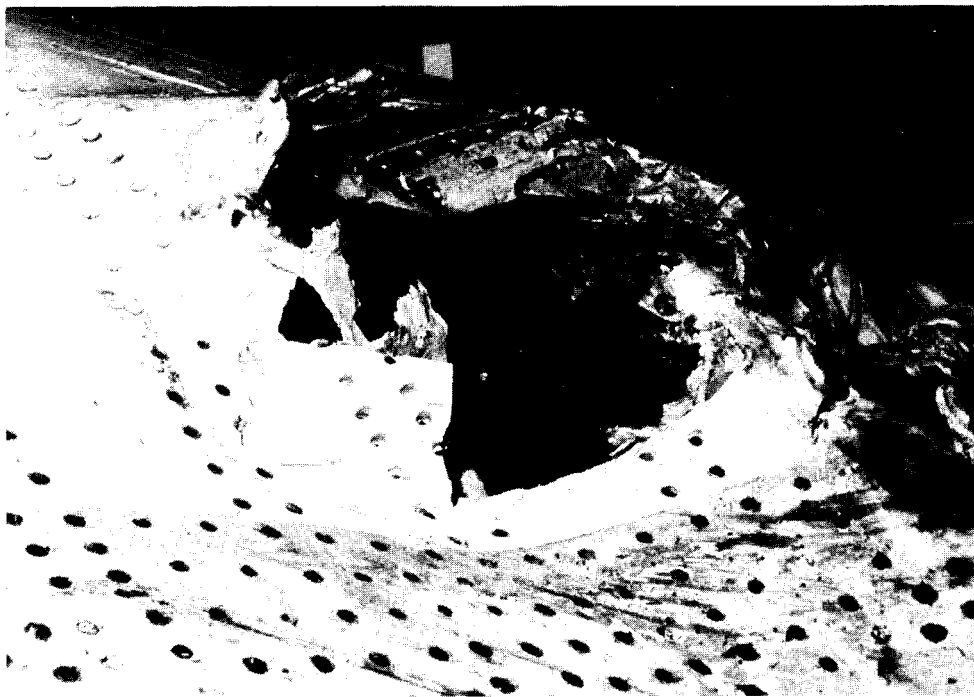
Our own examination of photographs of the wreckage found more evidence of possible explosions. Figure DO11. shows a substantial explosively ripped hole apparently on the underside of the aircraft. Figure DO12. shows an interior view. We could not establish the location on the aircraft, but the wide extent of battered and crushed ribs might be supposed to be the result of impact by material blown about by an explosion. Additional detail shown in Figure DO13. shows chips removed with no apparent local deformation. Such damage suggests high fracture rates typical of explosions.

Figure DO11. Hole apparently ripped by explosion

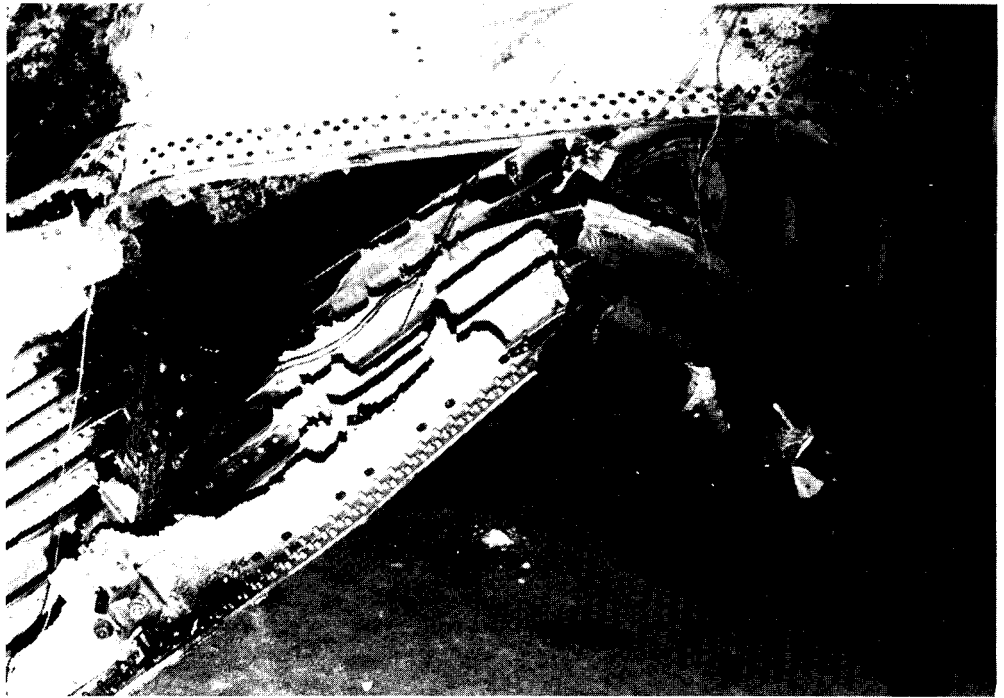
Figure DO13. Possible explosive fracture
